## 729182 PDM Harness Tech Bulletin

**Description of problem:** Lift Manifold connectors on the 729182 PDM Harness do not have enough flexibility after the branch to allow for easy installation of the connectors to the pressure sensor and lift valve solenoid.

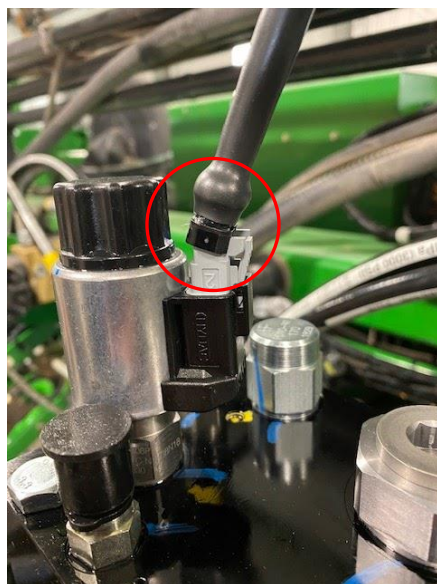
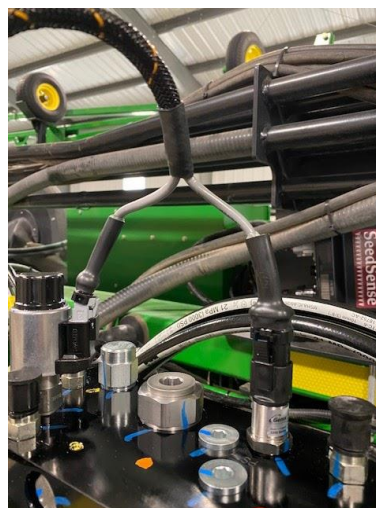
**Cause:** Harness manufacturer used adhesive lined heat shrink on the back side of the lift valve and pressure sensor connectors that may not allow the flexibility required for the harness to reach both connectors without imparting a side load on the connectors.

**Results:** Side load can cause damage to connectors (see photos below).

Precision Planting will be sending **729699 Solenoid Extension** to any dealer that was shipped the 729182, 729180, or 729210 between the affected dates. 729699 is a 12" extension for the 2 pin connector that connects to the Lift Valve Solenoid. This will allow more length between the 2 connectors and alleviates any strain on the connectors.

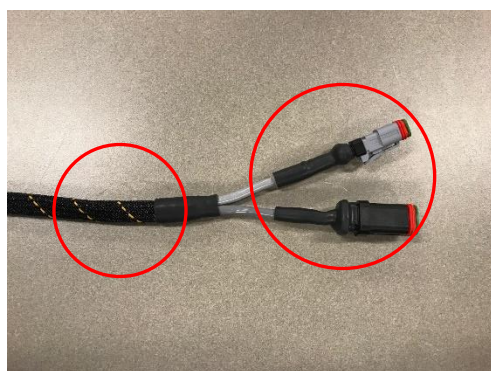
### Problematic Harness:

- Single yellow strand in the braided looming of the harness
- Heat shrink at the back of the connector with adhesive visible at the end of the heat shrink.

*Yellow strand in braided looming with heat shrink installed at back of connector.*

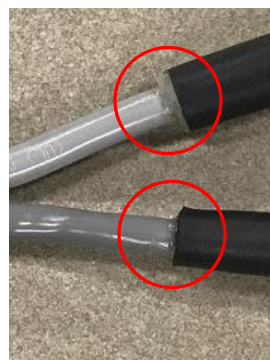
*Adhesive visible under heat shrink*

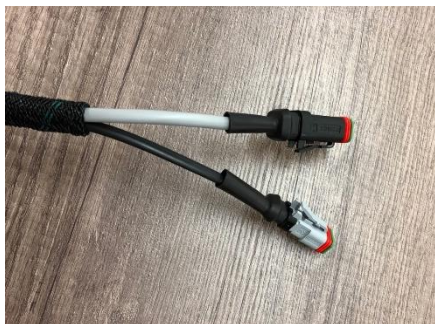
### Good Harnesses:

*No yellow strand in braided looming, heat shrink is present but with no adhesive, making it pliable.*

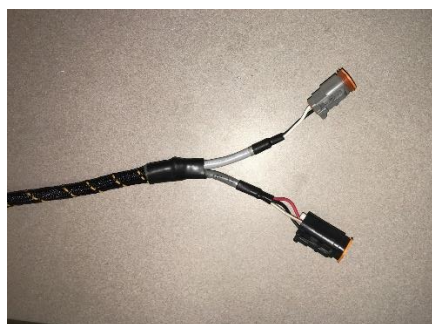
*Yellow strand is present in braided looming but no heat shrink on connectors.*
