## Service Bulletin: Terminals backing out of Deutsch connector of 72917X harnesses

January 27, 2014

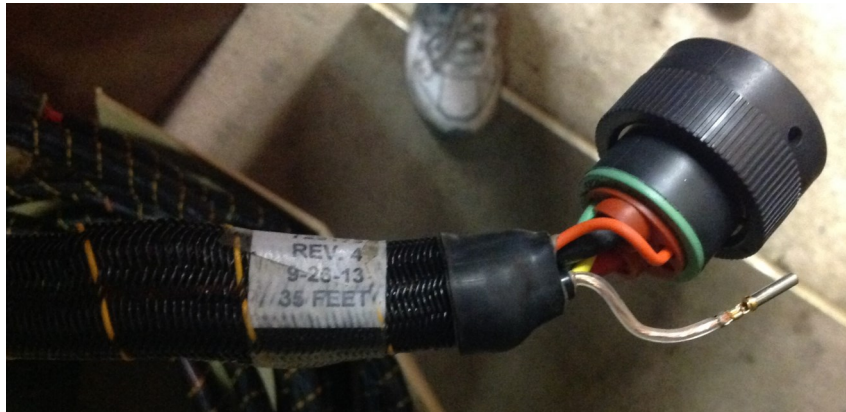
**Problem:** The terminals on the smaller wires can back out of the Deutsch connection of the Power/CAN Extension Harnesses (729170, 729171, 729172, 729173, 729174).

**Details:** We have identified a fault in the manufacture of the Power/Can Extension Harnesses where the 18AWG wires can back out of the Deutsch connector under hard flexing and twisting. This would occur at the planter hitch side of the extension, NOT at the PDM end of the harness. The fault is caused by some of the wires (the Orange and clear/white wires are most susceptible) being cut too short and not seating fully into the connector at the time of construction. See image below for example.

This fault should only be present on harness Revisions \_01 through \_05. We have updated our design to counter manufacturing problems and increase the robustness of this connection through over-molding and . Harness Revision \_06 (and subsequent versions should include this improvement and are not susceptible to the same type of fault.

Harnesses with this issue should be returned via an RMA process and will be replaced under warranty.
