## Service Bulletin: Weld Splatter on and around threads of Hydraulic Cylinder connections

January 27, 2014

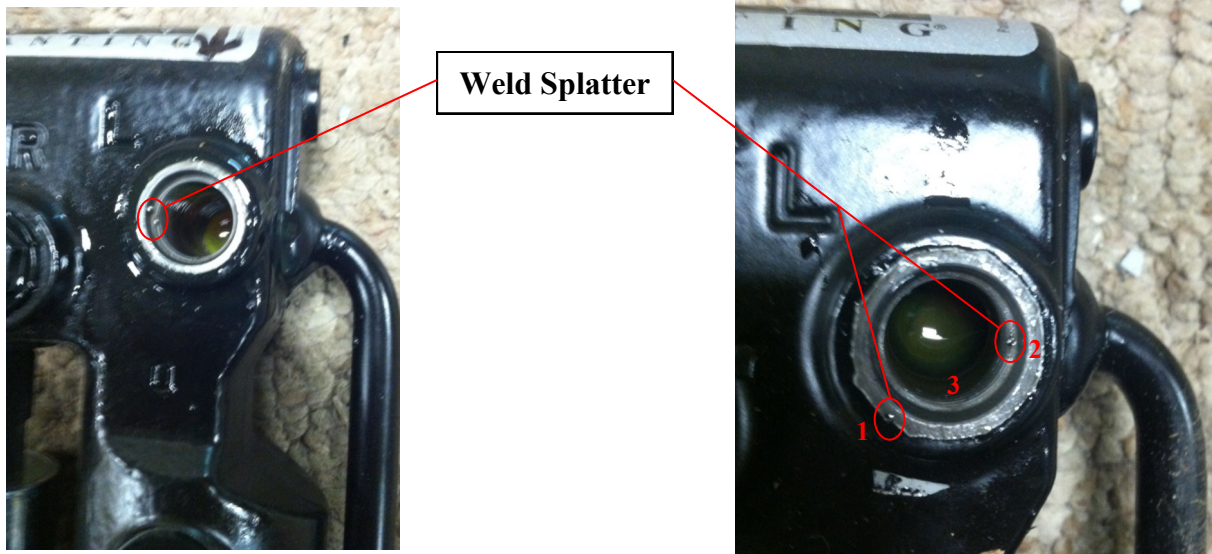
**Problem:** Weld berries or splatter found on and around the threads of the hydraulic cylinder (729600).

**Details:** We have identified a fault in our manufacturing process that failed to safeguard the threads on the 729600 Hydraulic Cylinder. This allowed weld splatter to collect in and around the threads of the hydraulic connections. It is most prevalent on the Lift Circuit connections, however can be present on any of the three connections.

1. Leaking at the hydraulic connection: If the splatter was on the face of the cylinder or in the O-Ring seat; locations **1** or **2** (see image above right), the weld splatter could damage the O-Ring or restrict the connector from seating properly to the cylinder.
2. Cylinder failure: If the splatter was in down into the threads; location **3** (see image above right), installing the hydraulic connection would dislodge the weld splatter introducing it as debris into the system. Outcome from this instance can range from nothing (flows through system harmlessly until capture by filter) to blockage/damage of the control valve or other internal component failures.

For un-installed cylinders, thoroughly inspect threads prior to installing hydraulic connectors; if weld splatter is present: DO NOT INSTALL; complete RMA process for complete replacement of cylinder.

For currently installed cylinders, we are NOT recommending removal or inspection processes. Recommendation is to complete all health checks and monitor cylinder performance closely. If weld splatter was present during installation, failure would present in one of two ways:
