# Banjo Strainer Manifold PTC Fitting Rework

We have identified an issue with the 1/4" PTC fittings in the Banjo strainer manifold. The PTC fittings were pressed in backwards preventing the collet from holding and allowing the hose to slide back out in some cases. This can result in a leaking connection or potentially blowing the hose off when pressure is built.

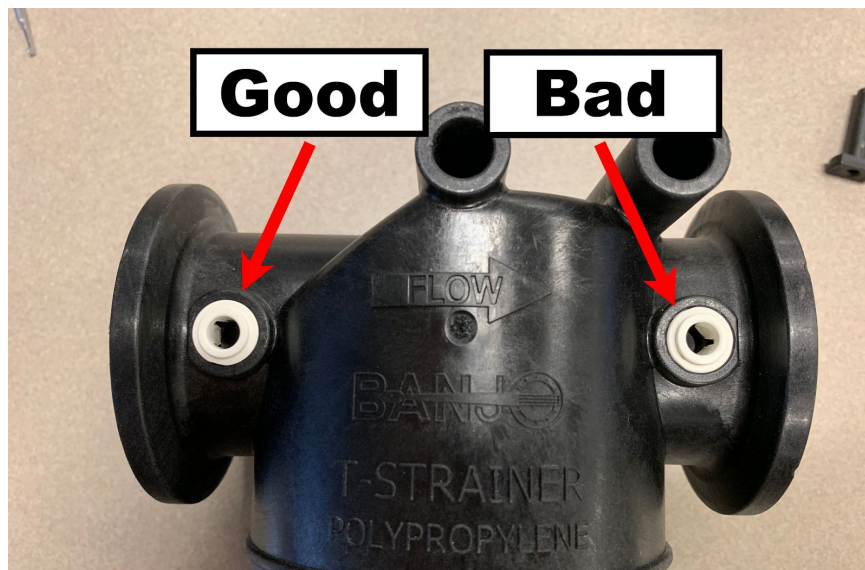
**1:** At a glance, it is not possible to tell the Good from the Bad PTC fitting.

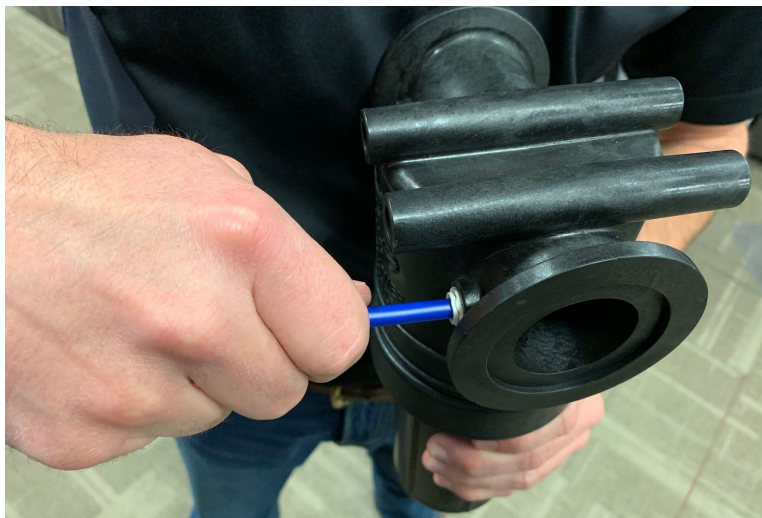
**2:** The fastest way to identify incorrectly installed PTC fittings is to pull firmly on the the 1/4" tubing. If the tubing does not hold fast, and slides right out, continue to the next step in order to repair the issue.

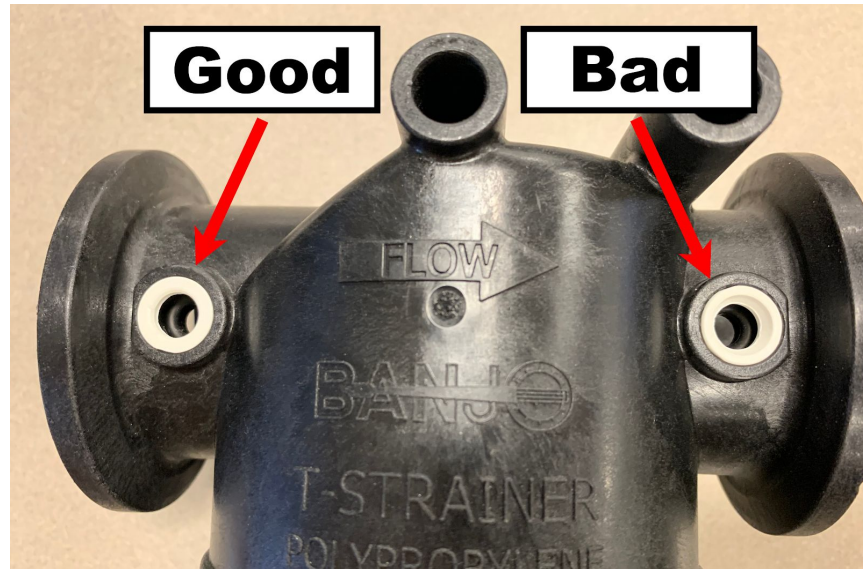
**3:** Using the pliers from your vApply Base Kit or FlowSense Essentials Kit, remove the collet from the PTC housing by prying up around the edge. You can now see that the PTC housing on the right is installed upside down.

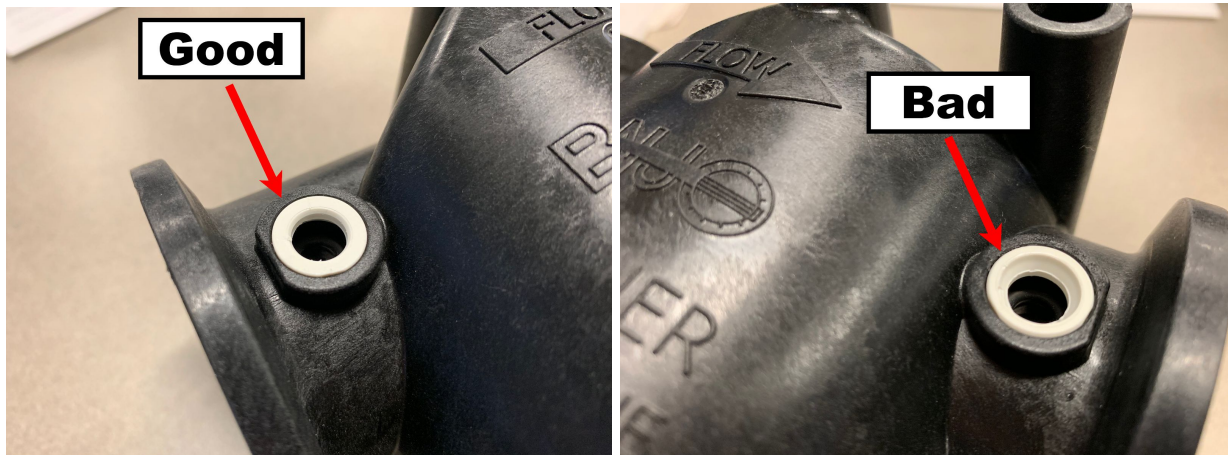
**4:** Close up images can better show that the bad fitting has been installed upside down
