## Tech Bulletin: JD Clean Grain Elevator Divider Plate Inspection

August 23, 2013

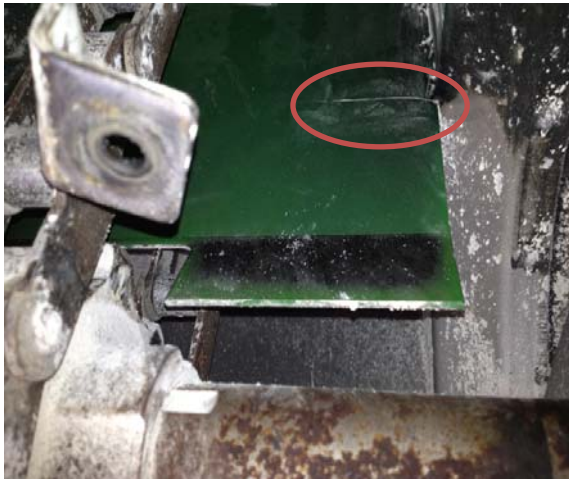
LOOK FOR CRACKS IN THE DIVIDER PLATE. THESE SHOULD BE WELDED.

**Solution:** When doing YieldSense installs, inspect the clean grain elevator divider plate for cracks or missing segments. Missing segments of the plate can cause paddle failures, so it is important for the divider to be repaired or replaced. When repairing dividers, add a reinforcement plate on the side which the paddles travel downward where there is more clearance. If rebuilding a section of missing plate, be sure to put a lead in angle on the bottom of the divider that points towards the front of the machine. Cracks should be repaired as they will continue to grow making the repair much more difficult if done in the future. This repair will be easiest to do when replacing the elevator chain.

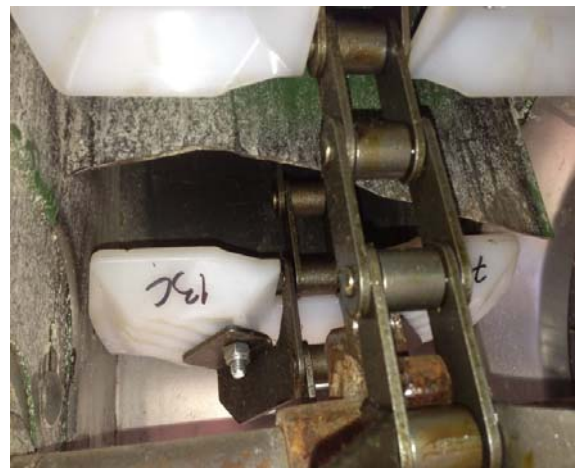
**Problem:** Broken clean grain elevator divider plates can create catch points causing high loading on plastic paddles.

BROKEN DIVIDER PLATE CAN BE A CATCH POINT FOR PLASTIC PADDLES.
